Manhole Inspection Summary

Manhole # S41CC_042MH

Insp Date: 11/10/08 1:40 PM

Location Address: **1207 ashland av**

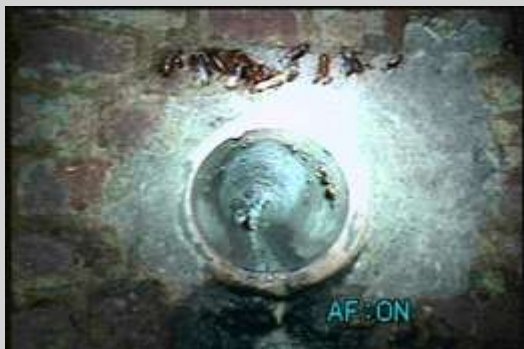
3 O'Clock Inflow

8 in. Circular Gravity Sewer
Pipe In @ 3 O'Clock

Invert Depth: 7.33 (ft.) Flow Characteristics: **None**

Infiltration: **None** Pipe Seal Cond: **Unknown**

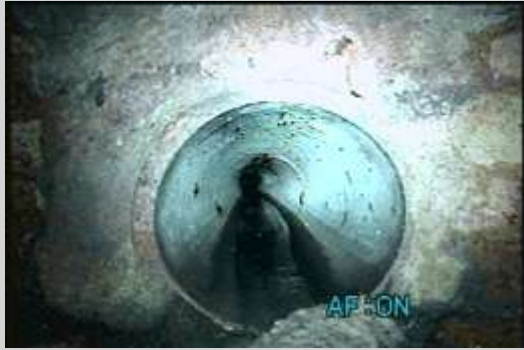
9 O'Clock Inflow

8 in. Circular Gravity Sewer
Pipe In @ 9 O'Clock

Infiltration: **None**
